PILOT LADDER MAINTENANCE, USE, REPLACEMENT & INSPECTION RECORD BOOK

Pilot Ladders - Care and Maintenance Instruction Manual

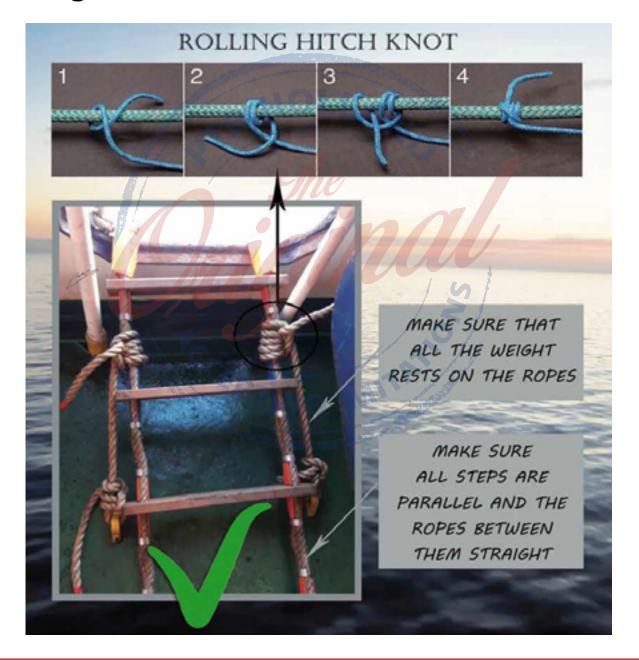
Examples acceptable Rigging for a Pilot Ladder

- Rigging of a ladder should be as per (page 13) of this instruction "How to Rig Pilot Ladder Properly" with the use of a Rolling Hitch Knot pictured below (page 13) shackles securing a ladder directly to pad-eyes on deck inboard / outboard should not be used.

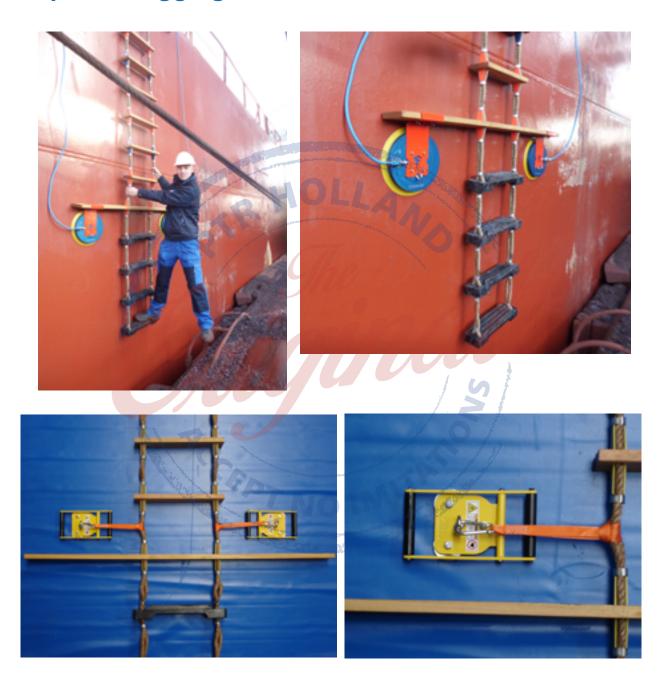
Examples acceptable Rigging for a Pilot Ladder

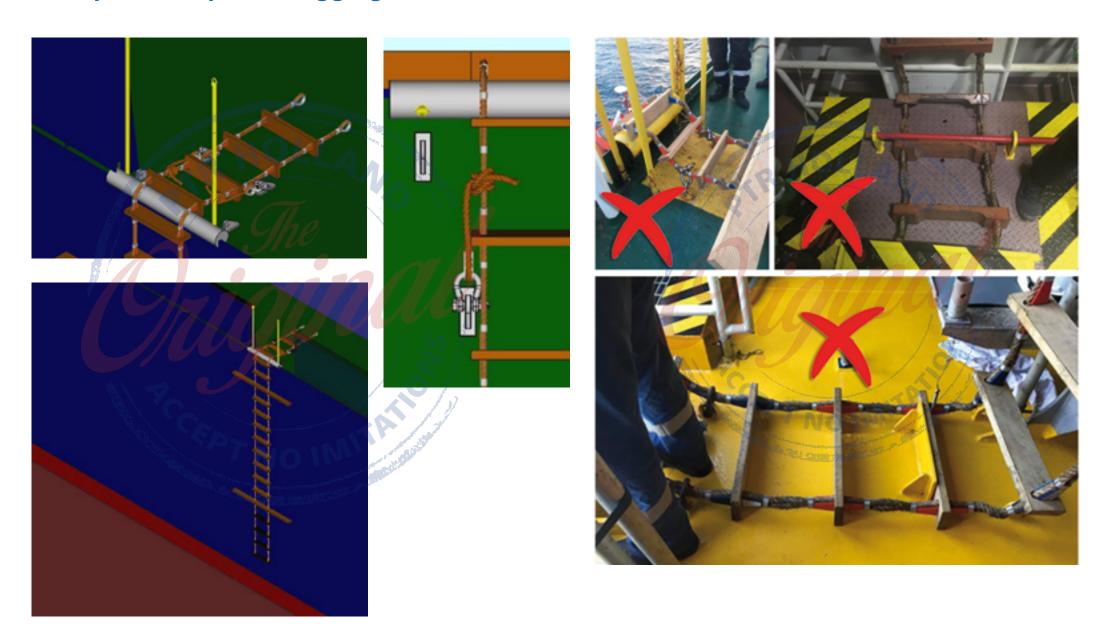
Examples unacceptable Rigging for a Pilot Ladder

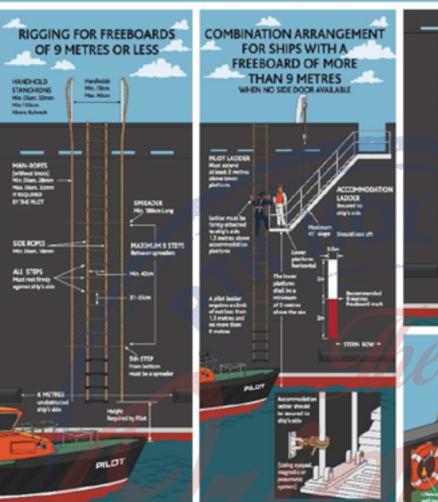
IMPA Pilot Ladder Poster:- Annex C (Informative)

REQUIRED BOARDING ARRANGEMENTS FOR PILOT In accordance with SOLAS Regulation V/23 & IMO Resolution A.1045(27) INTERNATIONAL MARITIME PILOTS' ASSOCIATION H.Q.S. "Wellington" Temple Stairs, Victoria Embankment, London WC2R ZPN Tel: +44 (0)20 7240 3973 Fax: +44 (0)20 7210 3518 Email: office@impahq.org This document and all IMO Pilot-related documents are available for download at: http://www.impahq.org

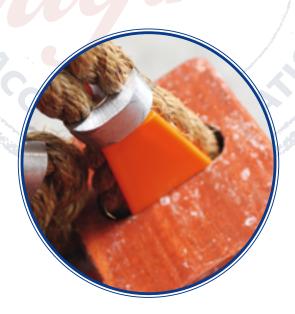
Repair step types ≥400 **1** 25 **\\55** <u>≥50</u> ≥1800 ≥400

- 1. The damaged step or spreader should be carefully removed along with the whippings above and below the step. Every care should be taken not to damage the side ropes during this operation.

- 2. The replacement step/spreader should have the chokes placed on either side of the step where the cut outs are. Half of the choke one side of step and half the other side of step.

- 3. The step/spreader should then be placed in the ladder with the side ropes on both sides running along the groove in the choke. The step/spreader should be placed mid distance between the upper and lower step.

- 4. A figure 8 seizing of 3 ply tarred marlin should then be applied both above and below the winnet on both sides of the ladder to hold them tightly in place. The whipping should consist of a minimum 38mm length around both ropes and should be locked off with by means of a double frapping and finished off by passing between the side ropes.

- 1. The damaged step or spreader should be carefully removed. Every care should be taken not to damage the side ropes and clamps during this operation.
- 2. The replacement step/spreader should then be slid into position with the grooves facing upwards between the 4 nylon chocks and set ready to take the nuts and bolts, these are tightened gradually securing the step in its new position.
